ROYAL AIRCRAFT ESTABLISHMENT

Technical Report 85059

**A COMPARISON OF THE FATIGUE
PERFORMANCE OF WOVEN AND
NON-WOVEN CFRP LAMINATES**

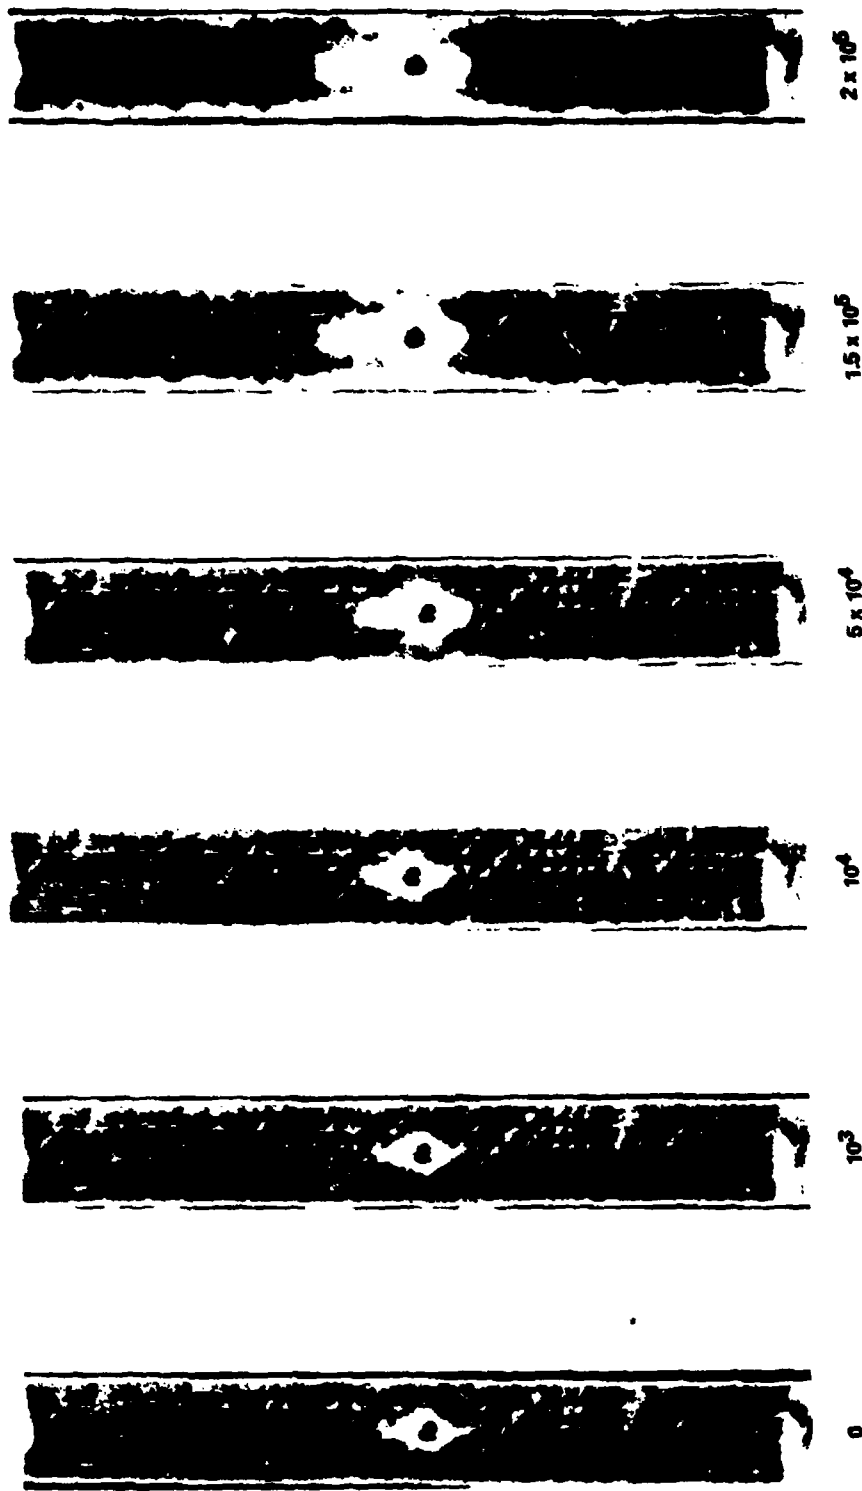
Fig 25 Ultrasonic C-scans of a non-woven holed coupon with layup D (0.90, ±45) tested in tensile fatigue at the stress level giving a mean life of 100000 cycles. Left to right, scans after: 0 cycles at 1 dB steps, 1000 cycles at 1 dB steps, 10000 cycles at 1 dB steps, 50000 cycles at 1 dB steps, 150000 cycles at 1 dB steps, 200000 cycles at 1 dB steps

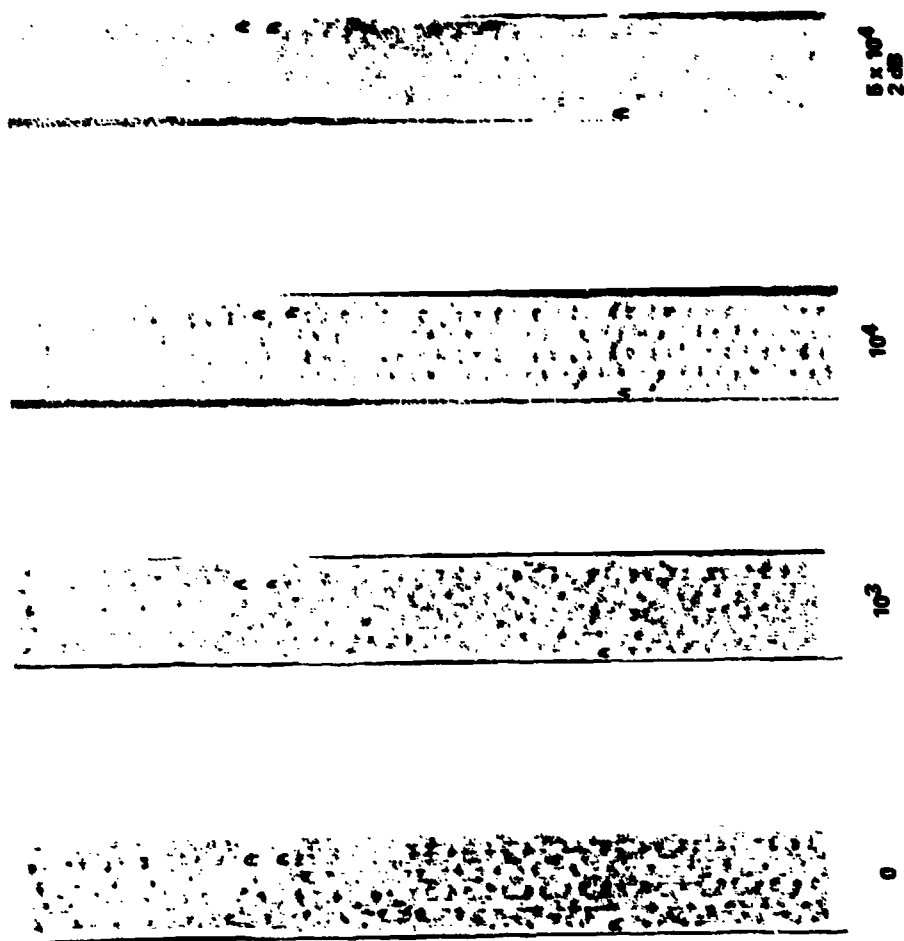
Fig 26 Ultrasonic C-scans of a woven plain coupon with layup D (0.90, ± 45) tested in tensile fatigue at the stress level giving a mean life of 100000 cycles. Left to right, scans after: 0 cycles at 1 dB steps, 10000 cycles at 1 dB steps, 50000 cycles at 2 dB steps

Ultrasonic C-scanning of plain woven coupons revealed an overall lightening with increasing numbers of cycles and the gradual development of lighter spots along the lines of intersection of woven tows (Fig 26), as in coupons from lay-up C, but no transverse light lines. Edge lightening was apparent, but this was very limited and never extended more than 1-2 mm from the coupon edges. Holed coupons showed more interesting behaviour with some edge lightening developing after 50000 cycles (Fig 27) together with evidence of light spots, albeit less obvious than in the plain woven coupons. The light areas that developed around the holes, as in the non-woven coupons, eventually linked up with the edge lightening and spread longitudinally along the coupon edges but not above or below the hole. At large numbers of cycles some intense white spots formed away from the hole area.

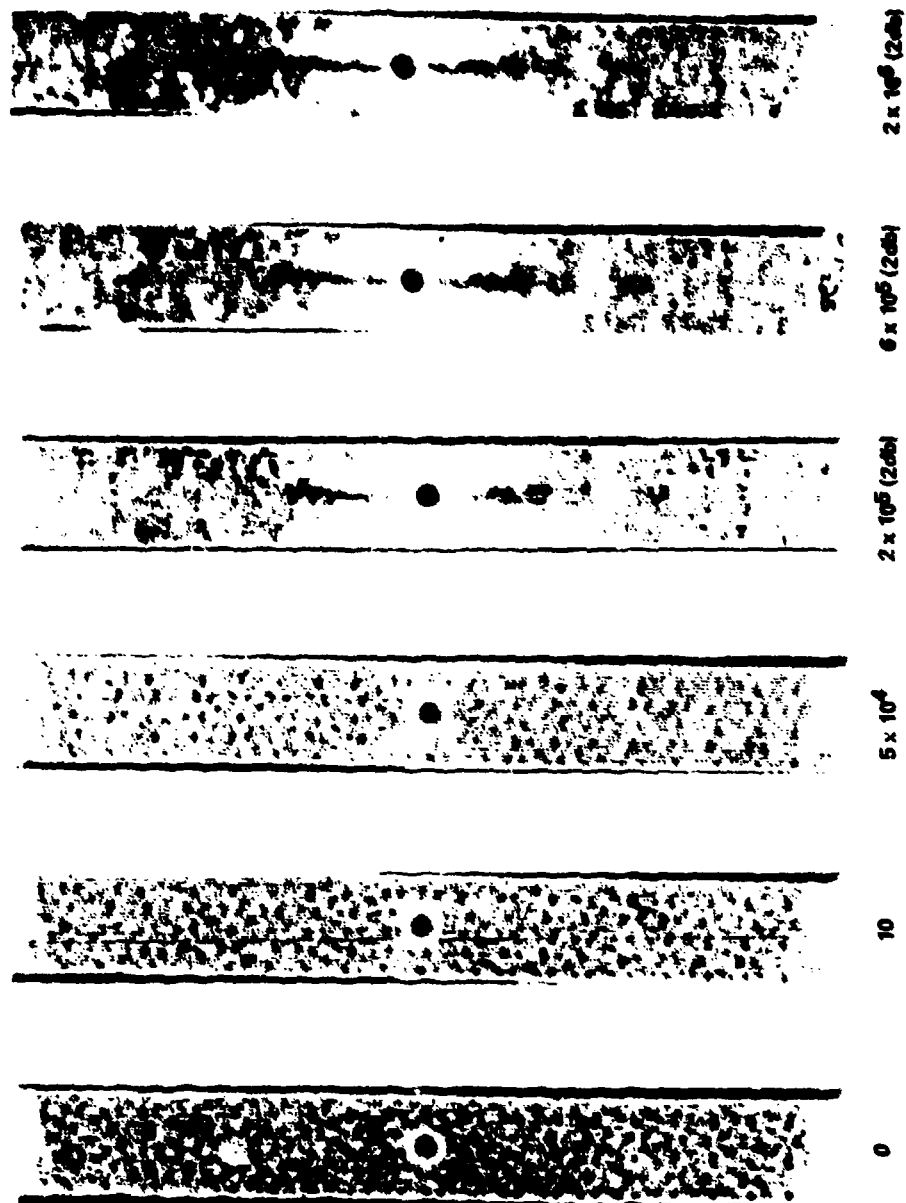
Fig 27 Ultrasonic C-scans of a woven hole coupon with layup D (0,90,±45) tested in tensile fatigue at the stress level giving a mean life of 100000 cycles. Left to right, scans after: 0 cycles at 1 dB steps, 10000 cycles at 1 dB steps, 50000 cycles at 1 dB steps, 200000 cycles at 2 dB steps, 600000 cycles at 2 dB steps, 2000000 at 2 dB steps

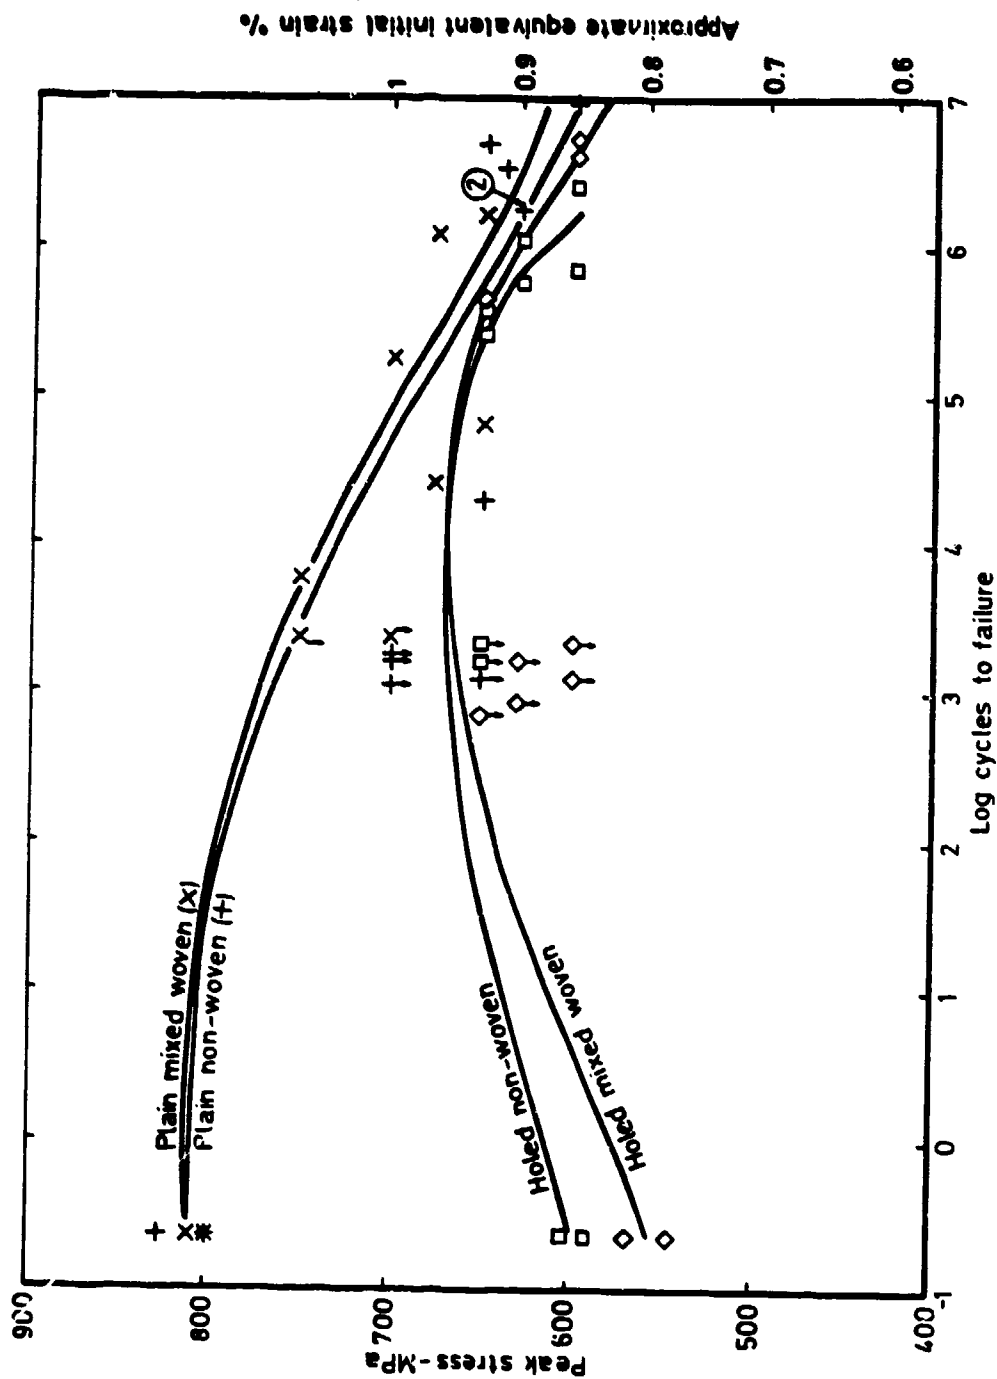
Fig 28 S-N plots of tensile fatigue data for layout E (145,02). A vertical arrow denotes run up failure

Results of the tensile fatigue tests are given in Table 10 and presented as S-N curves in Fig 28. All plain coupons failed at random positions along their lengths and holed non-woven coupons also failed away from the holes. Holed woven coupons failed through the holes at short lifetimes but those coupons surviving to long lifetimes failed away from the holes. Both woven and non-woven coupons showed evidence of edge splitting and delamination at long lifetimes.

The static tests on coupons with the $(\pm 45, 0_2)$ lay-up (lay-up E) showed there to be little difference in strength between the non-woven and mixed woven coupons, and a similar observation was made in the tensile fatigue tests (Fig 28). The plain coupons suffered a loss in strength of nearly 25% after 1 million load cycles in both the non-woven and mixed woven cases. Previous work had found a greater loss in strength in the non-woven material^{11,12}, but this was not the case in the present work. Microstructural analysis revealed the damage to be confined mainly to the $\pm 45^\circ$ layers, which carry only a small fraction of the applied load. Thus the coupons behaved in a similar manner to unidirectional material, and indeed the loss in strength during fatigue was comparable with that observed in unidirectional material. C-scans of the plain mixed woven coupons did reveal damage at tow crossover points in the $\pm 45^\circ$ layers, but since these layers carried only small loads the damage had no significant effect on the material strength.

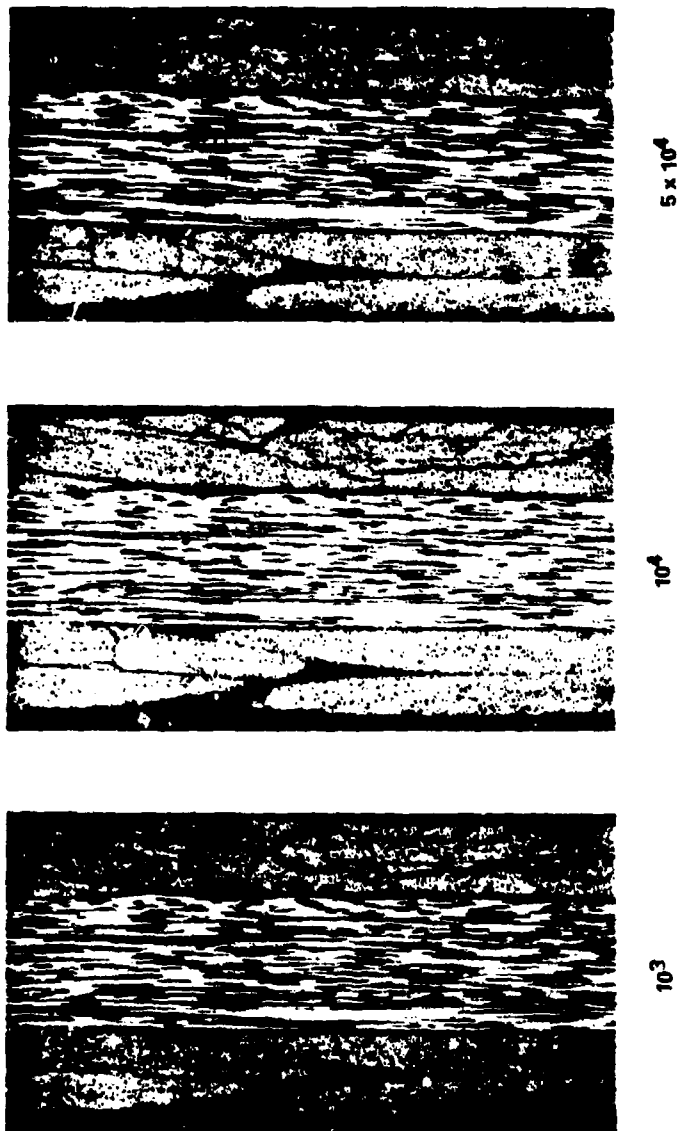
Fig 30 Optical micrographs of woven plain coupons with layup E (±45,02) tested in tensile fatigue at the stress level giving a mean life of 100000 cycles. Left to right, micrographs after: 1000 cycles, 10000 cycles, 50000 cycles

Optical microscopy of plain woven and non-woven coupons revealed $\pm 45^\circ$ delamination and translaminar cracking after only 1000 cycles (Fig 29). This became more extensive after 10000 and 100000 cycles (Figs 29 and 30). Above 100000 cycles there was evidence of fibre damage in the 0° fibres (Fig 30).

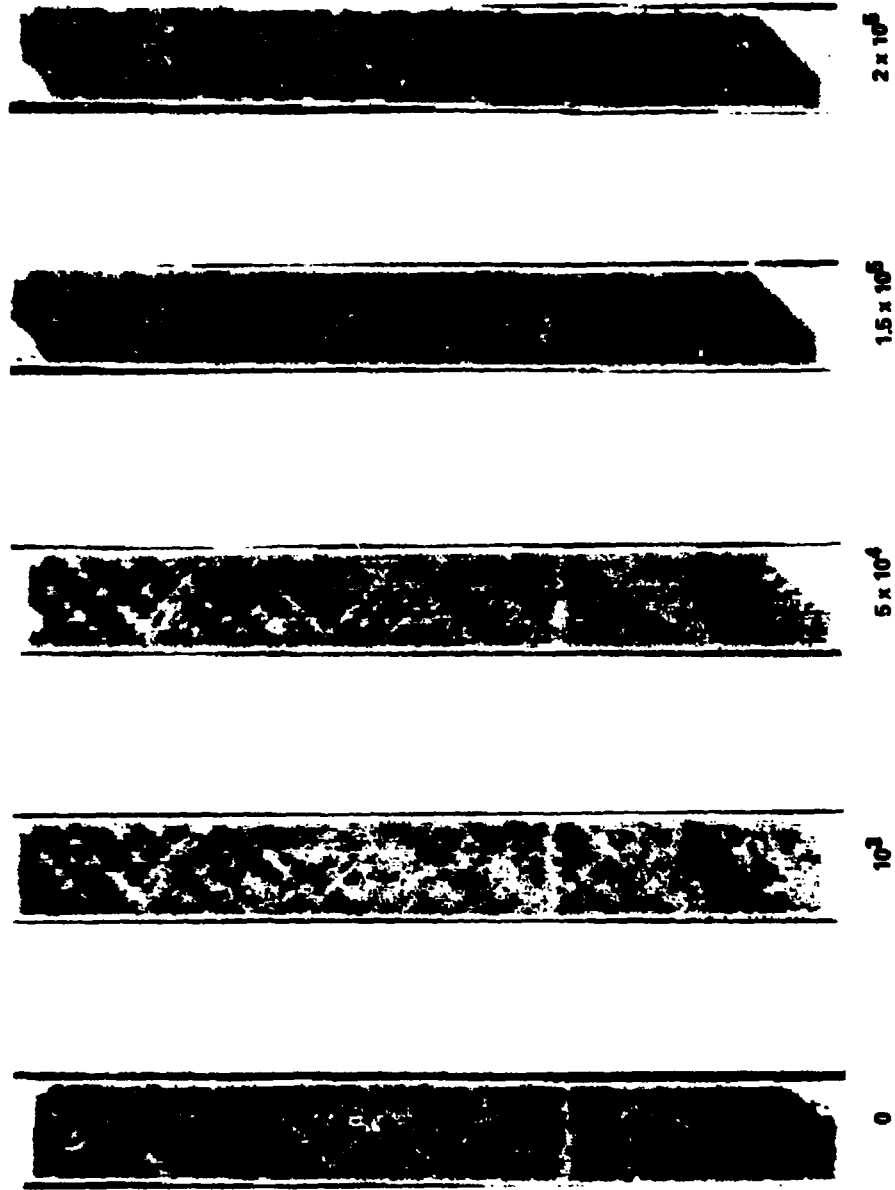
Fig 31 Ultrasonic C-scans of a non-woven plain coupon with layout E ($\pm 45,02$) tested in tensile fatigue at the stress level giving a mean life of 100,000 cycles. Left to right, scans after: 0 cycles at 1 dB steps, 1000 cycles at 1 dB steps, 50,000 cycles at 1 dB steps, 150,000 cycles at 1 dB steps, 200,000 cycles at 1 dB steps

Ultrasonic C-scanning of plain non-woven coupons revealed little apart from a slight lightening after 1000 cycles and some evidence of damage growth around the coupon ends after large numbers of cycles (Fig 31). Holed non-woven coupons revealed damage around the holes after 10000 cycles (Fig 32) which grew longitudinally to a distance of several hole diameters after one million cycles. Eventually the damage reached the coupon ends and had also grown across the coupon width (Fig 32).

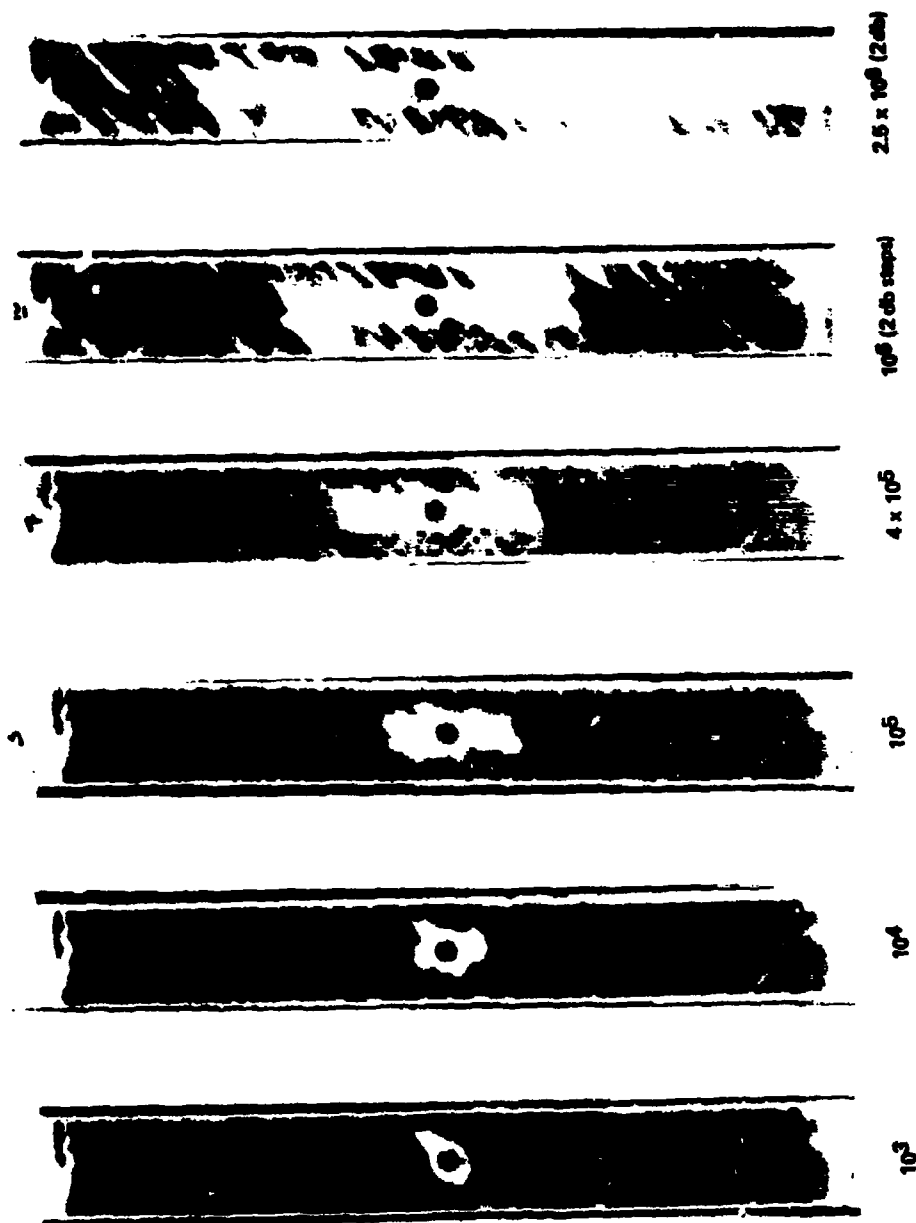
Fig 32 Ultrasonic C-scans of a non-woven holed coupon with layup E ($\pm 45, 0/2$) tested in tensile fatigue at the stress level giving a mean life of 1000000 cycles. Left to right, scans after: 1000 cycles at 1 db steps, 10000 cycles at 1 db steps, 100000 cycles at 1 db steps, 400000 cycles at 1 db steps, 1000000 cycles at 2 db steps, 2500000 cycles at 2 db steps

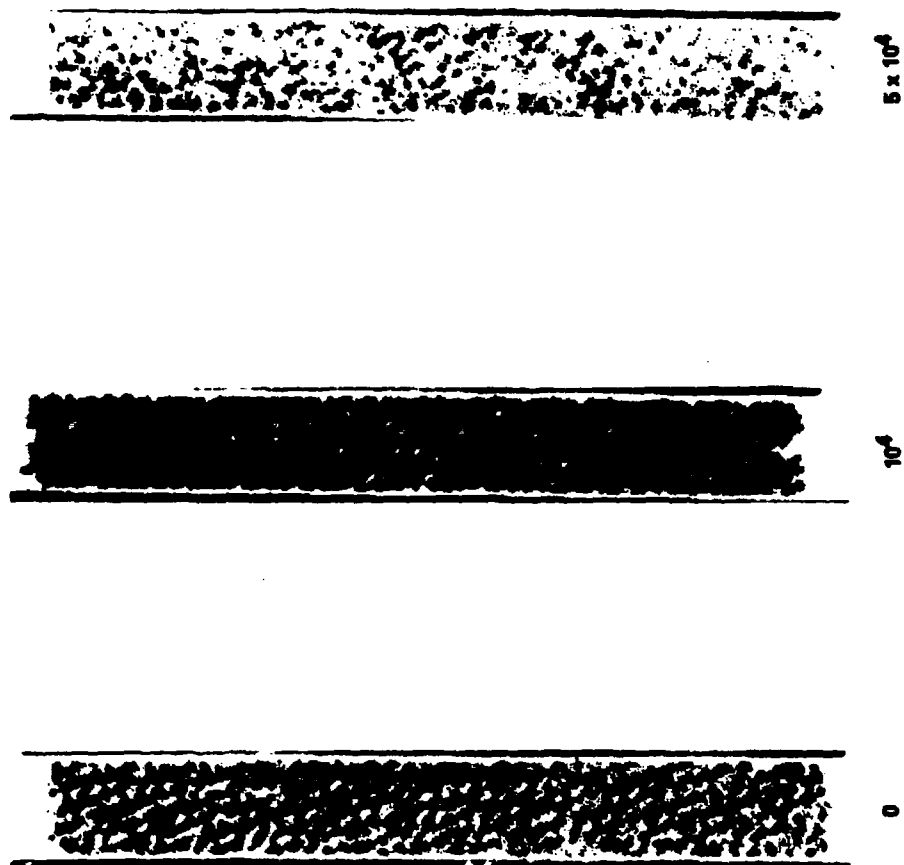
Fig 33 Ultrasonic C-scans of a woven plain coupon with layout E ($\pm 45, 0/2$) tested in tensile fatigue at the stress levels indicated. The mean life of 100,000 cycles. Left to right, scans after: 0 cycles at 1 dB steps, 10,000 cycles at 1 dB steps, 50,000 cycles at 1 dB steps

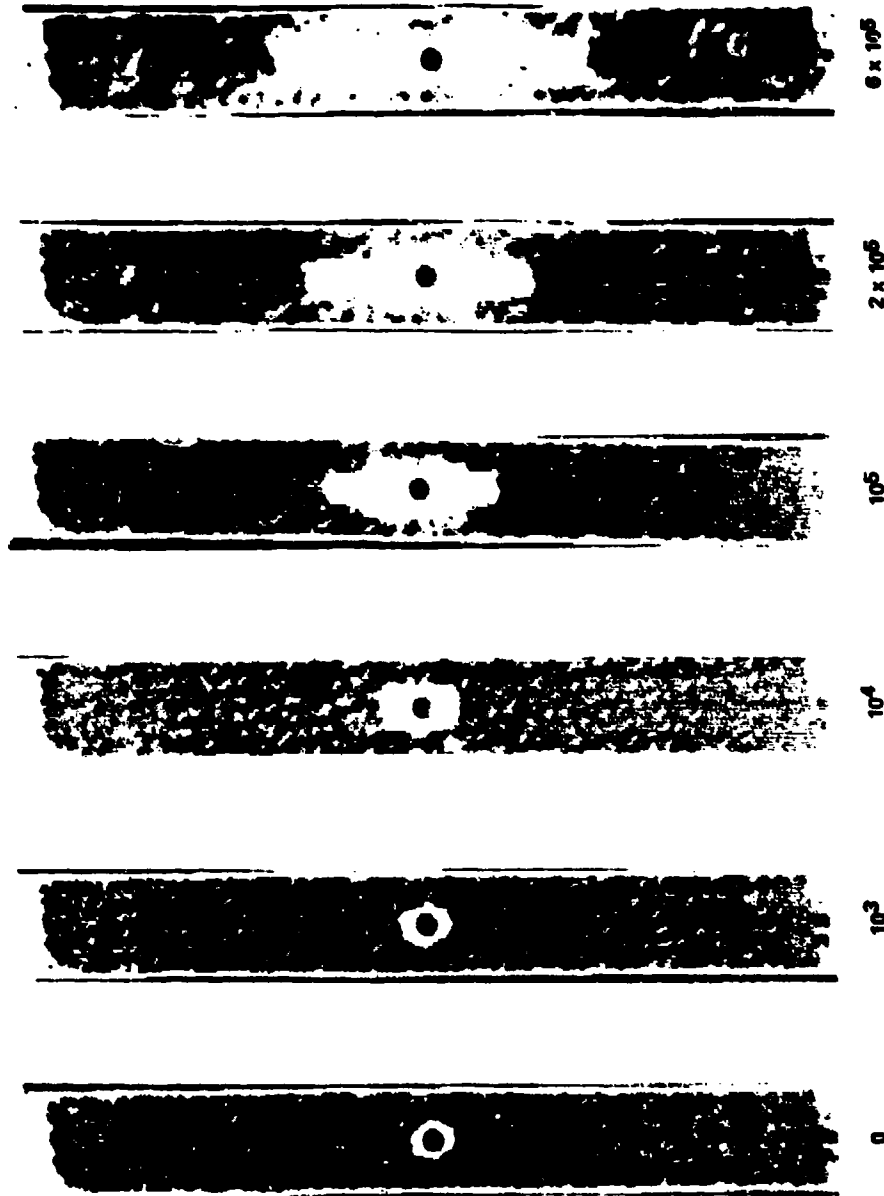
Fig 34 Ultrasonic C-scans of a woven hole coupon with layup E ($\pm 45, 02$) tested in tensile fatigue at the stress level giving a mean life of 100000 cycles. Left to right, scans after: 0 cycles at 1 dB steps, 1000 cycles at 1 dB steps, 10000 cycles at 1 dB steps, 100000 cycles at 1 dB steps, 200000 cycles at 1 dB steps, 600000 cycles at 1 dB steps

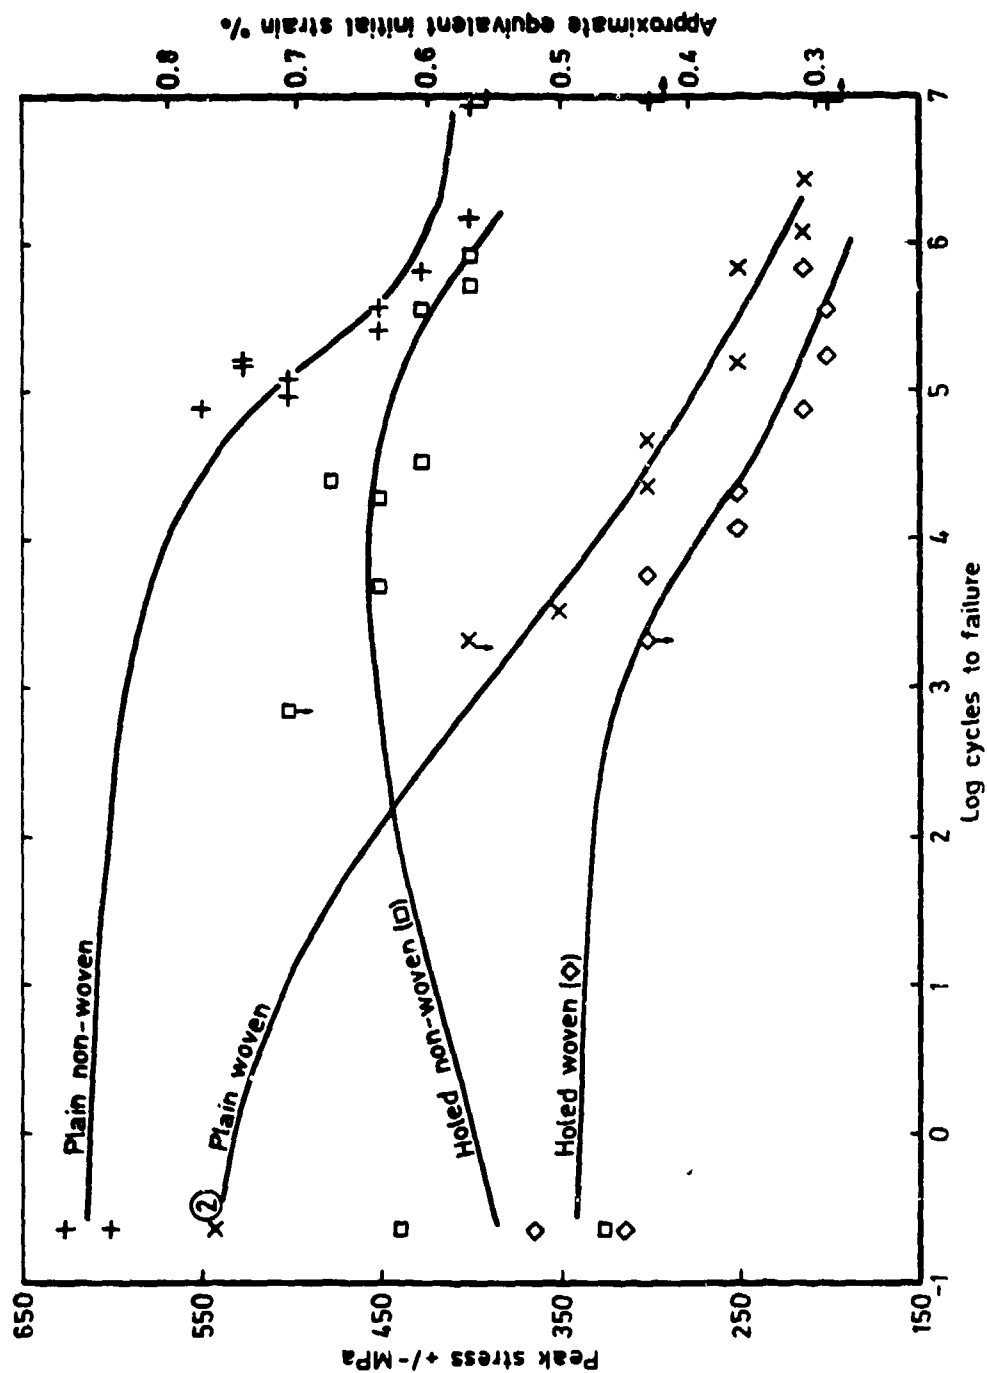
Fig 35 S-N plots of reversed axial fatigue data for layout A (0,90). Vertical arrows denote run up failures and horizontal arrows run-outs

During the reversed axial fatigue loading of plain coupons from lay-up A (0,90), a significant loss in strength was observed (Fig 35), much greater than observed during zero-tension loading. The loss in strength was greatest in the woven coupons, where after 1 million cycles the peak fatigue stress was less than half the static strength. Edge cracking was observed in plain non-woven coupons as well as translaminal 90° layer cracks early in the life, which spread to form 0/90 delamination at greater numbers of cycles. Although the plain woven coupons suffered a greater strength loss in reversed axial fatigue than the non-woven coupons, they developed less extensive damage; some edge cracking was visible and also 90° cracks, followed at long lifetimes by local 0/90 delamination confined to individual 0 fibre tows by the weave of the fabric. Damage was also visible at the tow crossover points as observed during the tensile fatigue work.

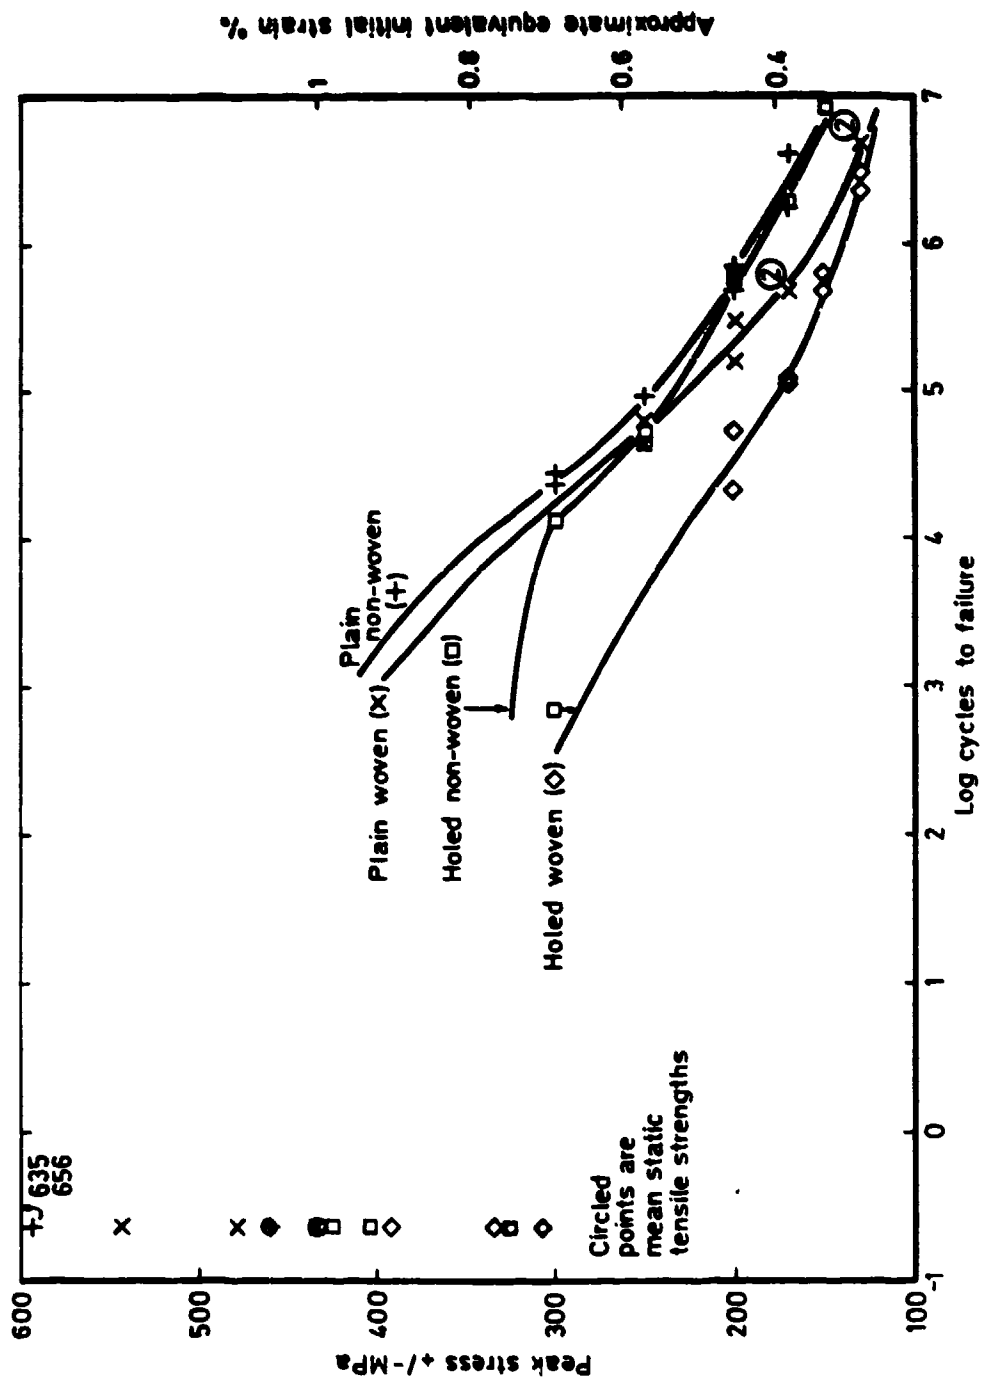
Fig 41 S-N plots of reversed axial fatigue data for layout C ($\pm 45, 0, 90$). Both tensile and compressive static data are presented at the 0.25 cycle point. Vertical arrows denote run up failures

Reversed axial fatigue tests on coupons with lay-up C (±45,0,90) yielded the S-N curves given in Fig 41. Since the tensile static strengths were less than the compressive

strengths these have also been plotted in Fig 41 as circled values. Thus in the reversed axial case the tensile excursion dominated at very short lifetimes. After only a small number of cycles however, compression behaviour prevailed and all coupons failed in compression at smaller stresses than in the tensile fatigue tests. All coupons exhibited steeply sloping S-N plots with a greater loss in strength than observed in tension alone. Static differences between plain woven and non-woven coupons were preserved in reversed axial fatigue, and indeed increased at long lifetimes. The peak fatigue stress for the plain non-woven material was reduced to about 195 MPa after 1 million cycles and 150 MPa for the plain woven material.

Unlike lay-up C, the static compressive strengths of plain coupons with lay-up D (0,90, ± 45) were similar to, perhaps slightly lower than, their tensile strengths. This was because lay-up D was not susceptible to the serious edge delamination effect observed in coupons with lay-up C. Hence the reversed axial fatigue S-N plots in Fig 41 were

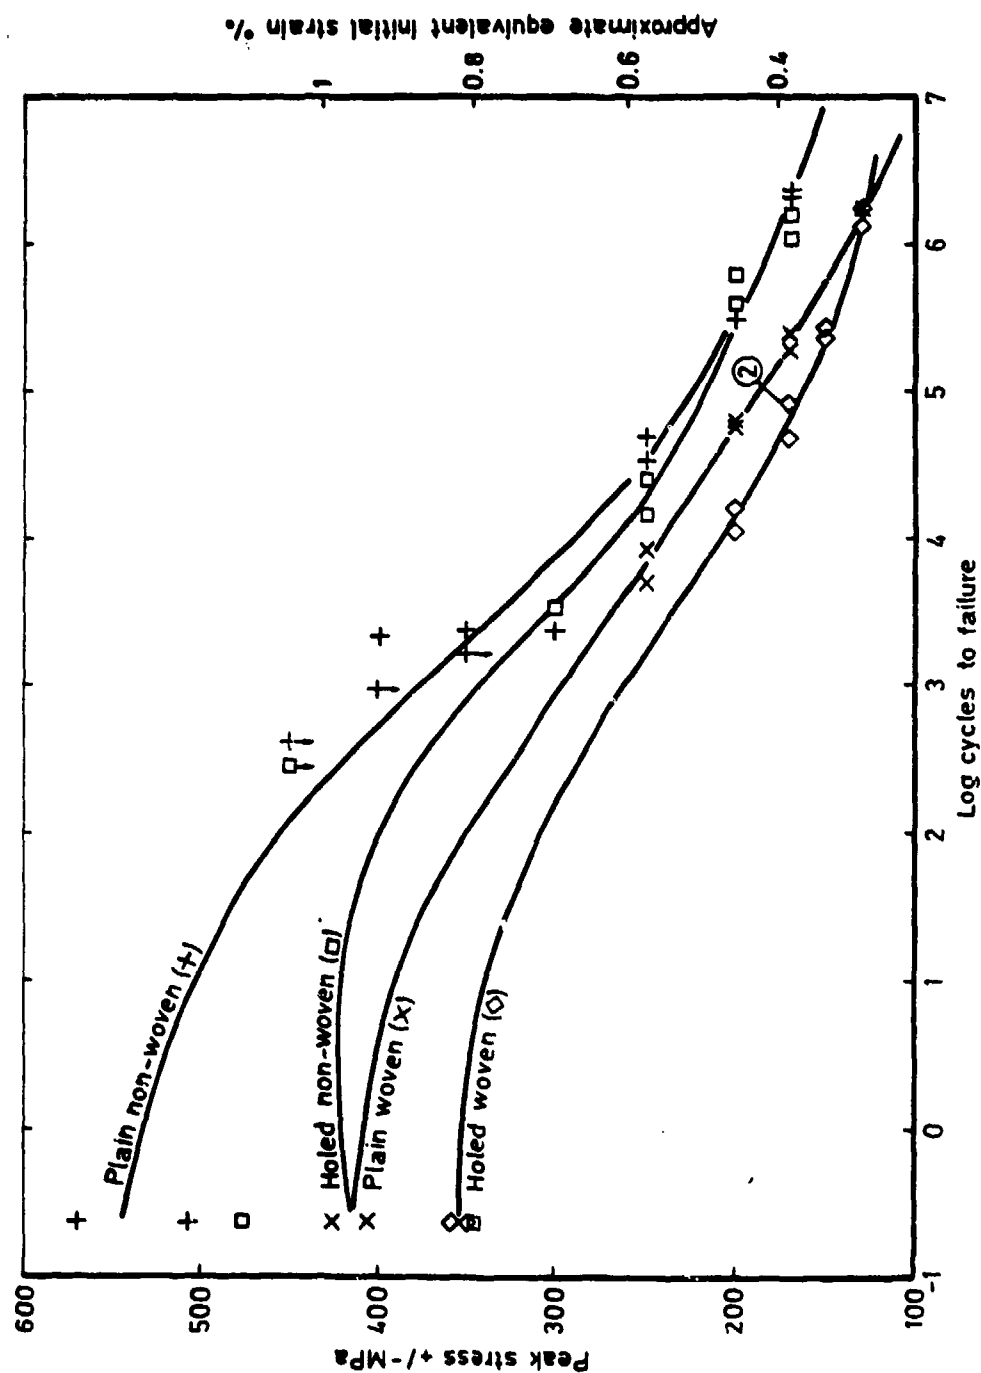
Fig 48 S-N plots of reversed axial fatigue data for layup D (0,90,45). Vertical arrows denote run up failures

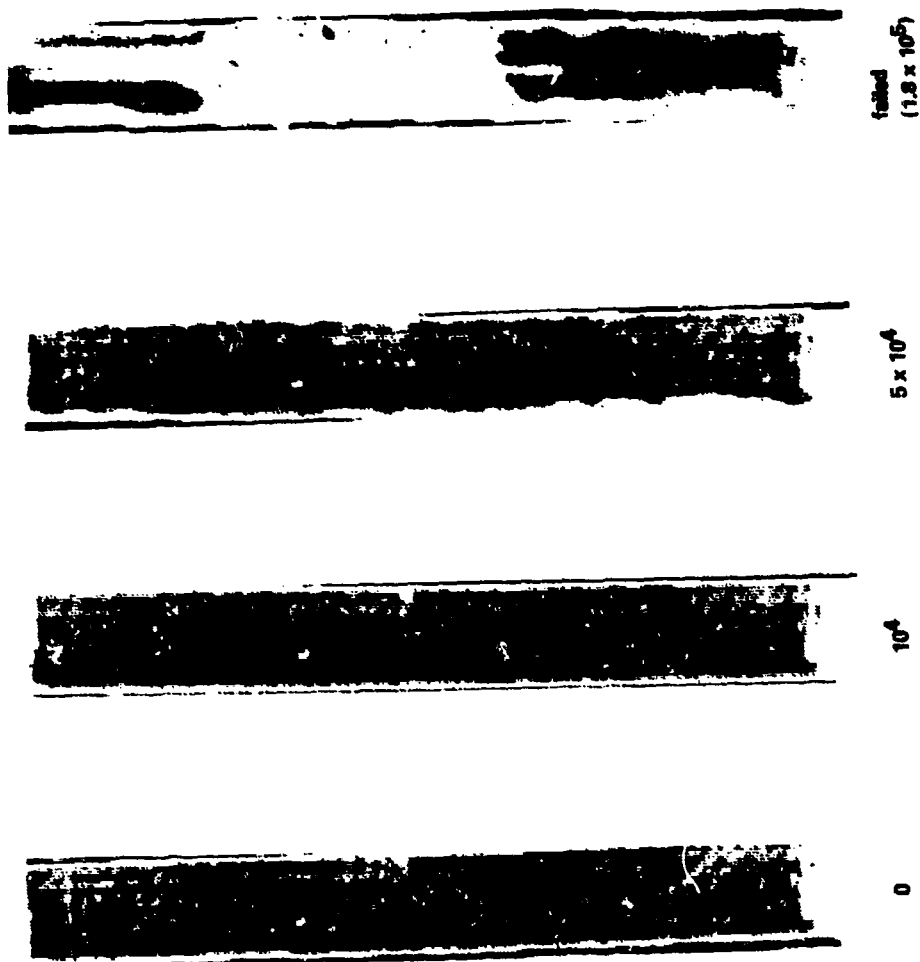
Fig 51 Ultrasonic C-scans of a non-woven plain coupon with layout D (0.90 ± 45) tested in reversed axial fatigue at the stress level giving a mean life of 100,000 cycles. Left to right, scans after: 0 cycles at 1 dB steps, 10,000 cycles at 1 dB steps, 50,000 cycles at 1 dB steps, 180,000 cycles at 1 dB — failure

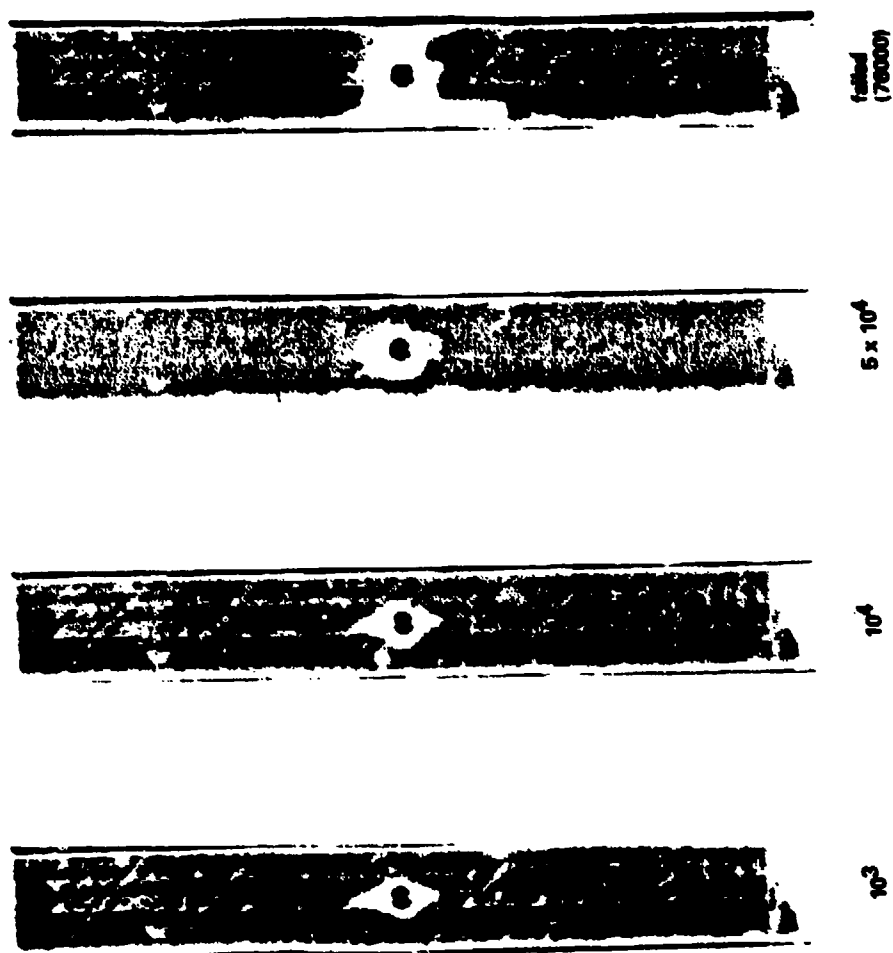
Fig 52 Ultrasonic C-scans of a non-woven holed coupon with layup D (0.90 \pm 46) tested in reversed axial fatigue at the stress level giving a mean life of 100000 cycles. Left to right, scans after: 1000 cycles at 1 dB steps, 10000 cycles at 1 dB steps, 50000 cycles at 1 dB steps, 76000 cycles at 1 dB steps, failure

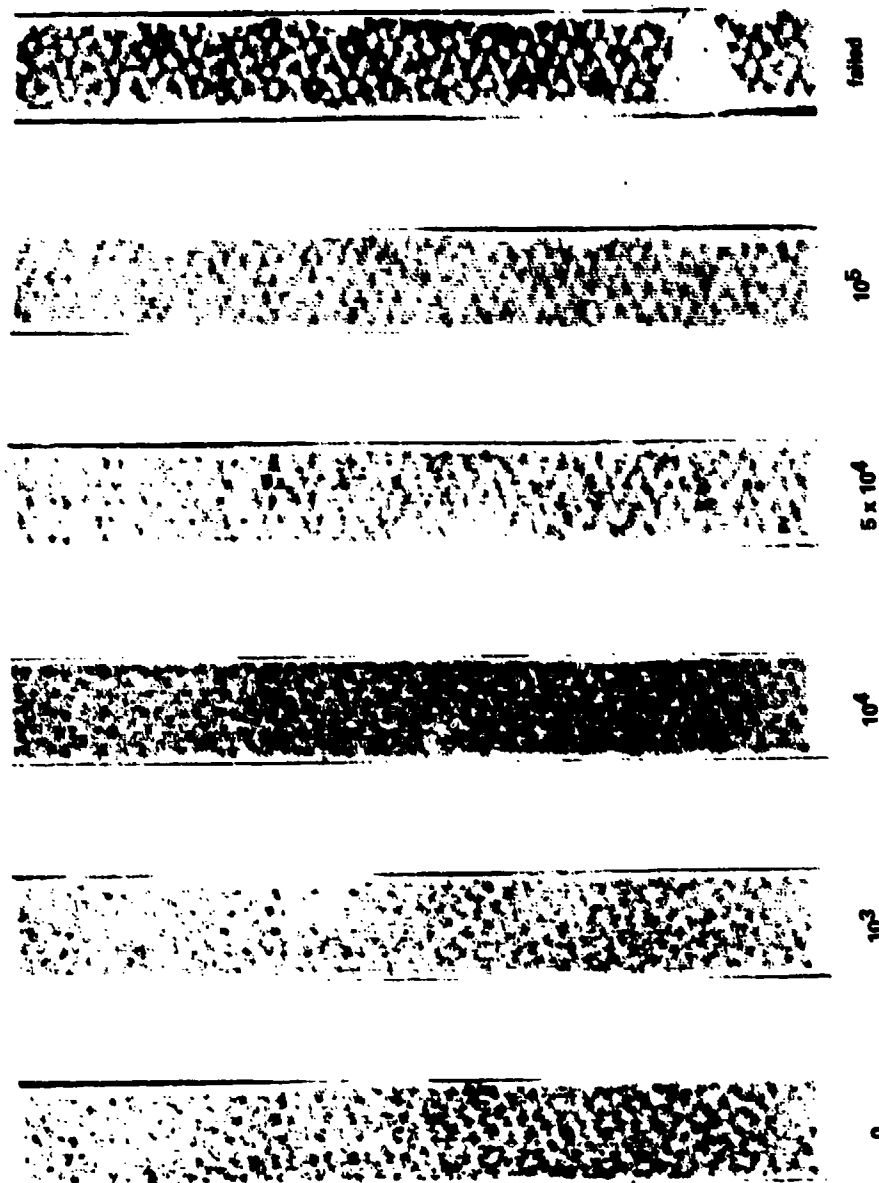
Fig 53 Ultrasonic C-scans of a woven plain coupon with layup D (0, 90, ± 45) tested in reversed axial fatigue at the stress level giving a mean life of 100,000 cycles. Left to right, scans after: 0 cycles at 1 dB steps, 1000 cycles at 1 dB steps, 10,000 cycles at 1 dB steps, 50,000 cycles at 1 dB steps, 100,000 cycles at 1 dB steps, failure

Ultrasonic C-scanning of plain woven coupons revealed an overall lightening with increasing numbers of cycles and the gradual development of lighter spots at the tow crossover points in the weave (Fig 53) as in coupons from lay-up C. Edge lightening was observed, but this was very limited and never extended more than 2-3 mm from the coupon edges. Holed coupons showed similar behaviour with some edge lightening developing after 100000 cycles (Fig 54). There was also evidence of the development of light spots but less obvious than in the plain woven coupons. The light areas that developed around the holes, as in the non-woven coupons, eventually linked up with the edge lightening and spread a short distance longitudinally along the coupon edges.

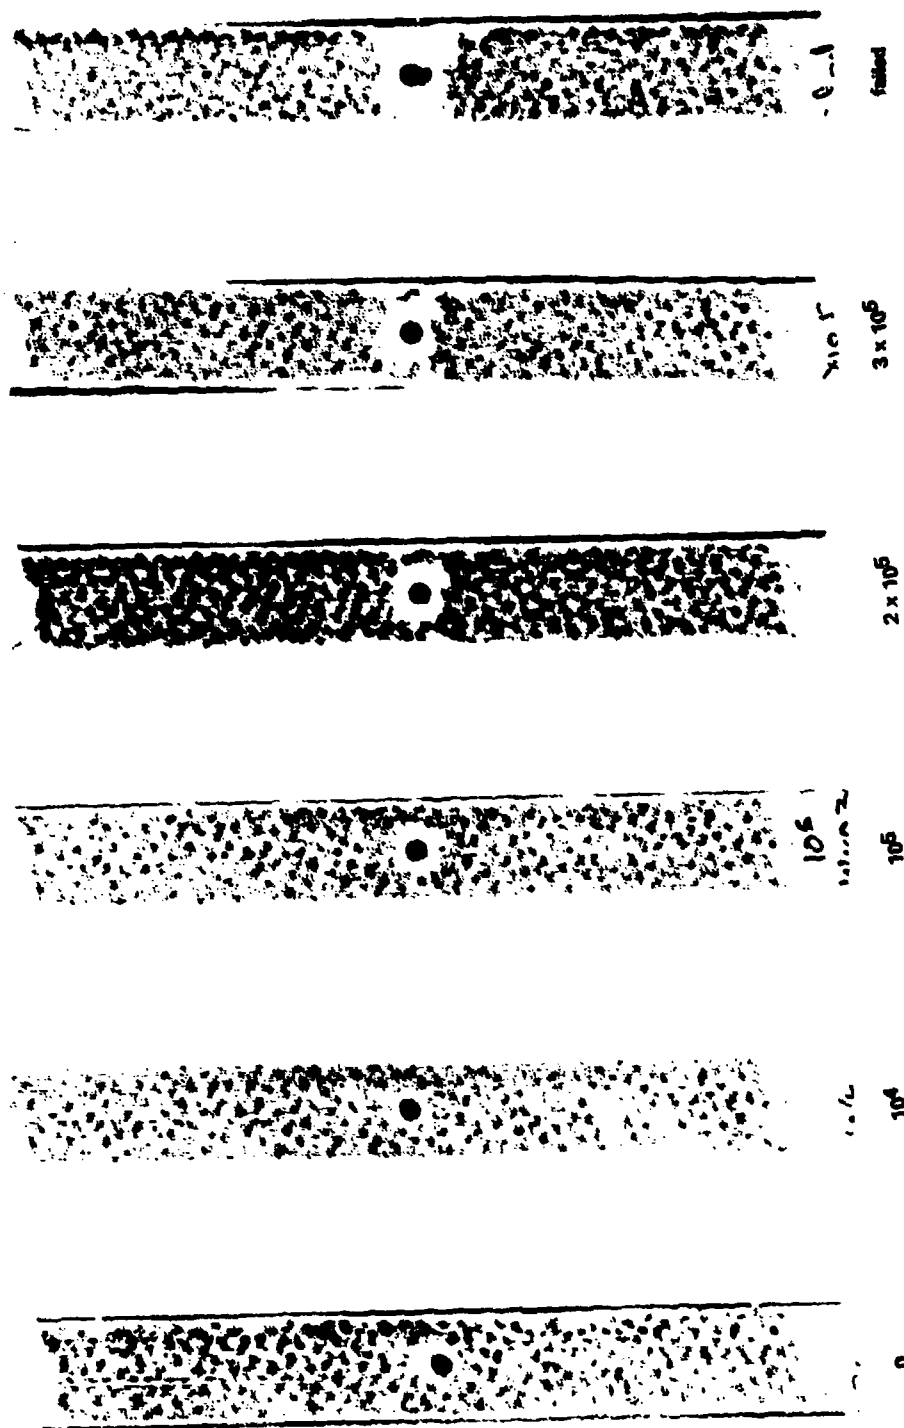
Fig 54 Ultrasonic C-scans of a woven holed coupon with layout D (0.90, \pm .45) tested in reversed axial fatigue at the stress level giving a mean life of 100,000 cycles. Left to right, scans after: 0 cycles at 1 dB steps, 10,000 cycles at 1 dB steps, 100,000 cycles at 1 dB steps, 200,000 cycles at 1 dB steps, 300,000 cycles at 1 dB steps, failure

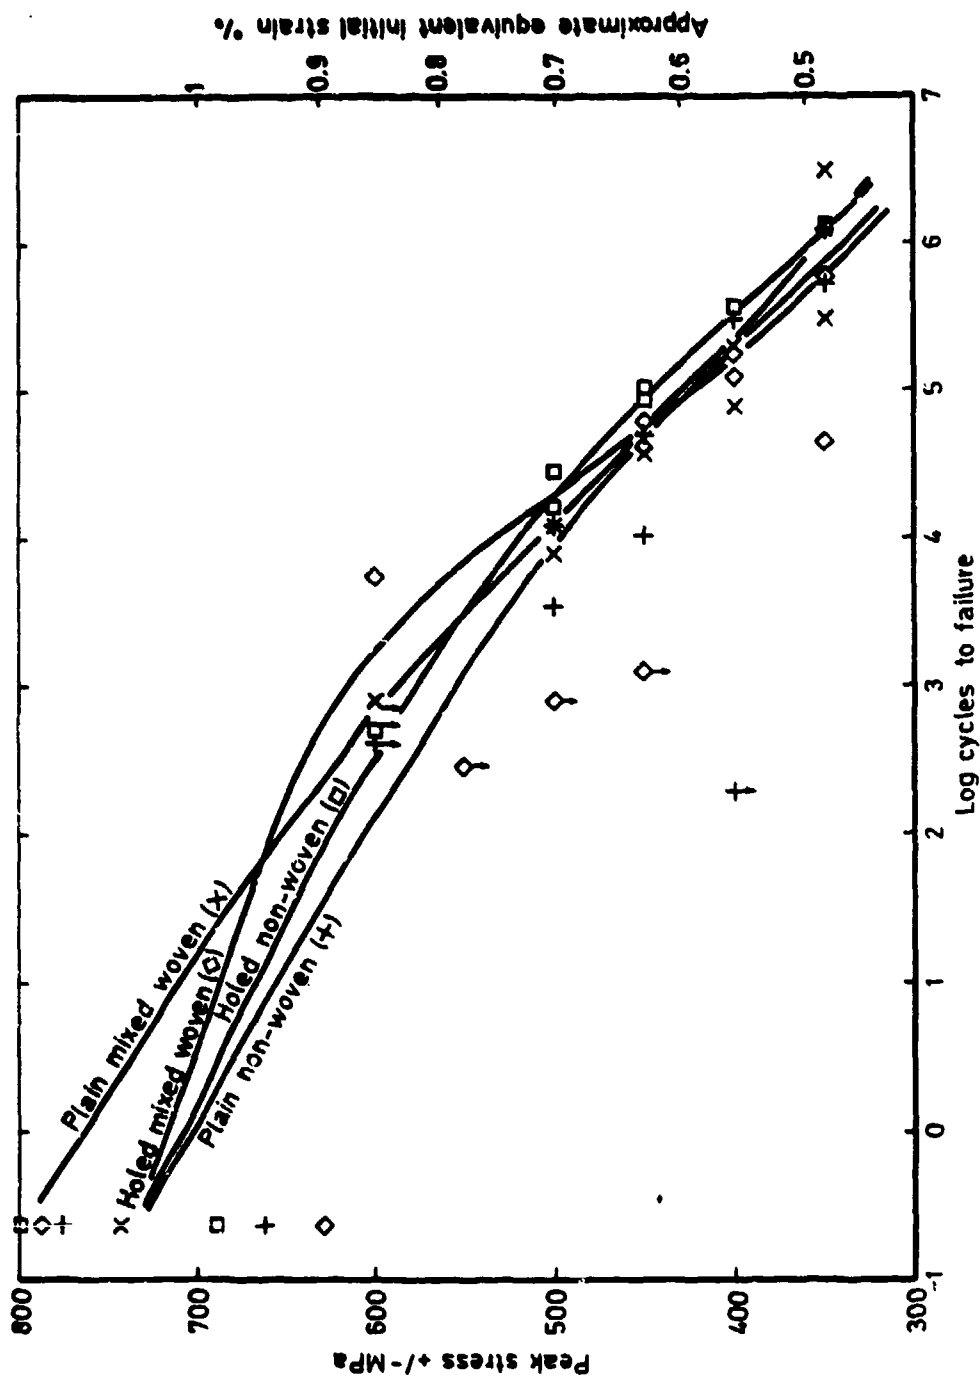
Fig 55 S-N plots of reversed axial fatigue data for layout E (±45,02). Vertical arrows denote run up failures

Results of the reversed axial fatigue tests are given in Table 14 and presented as S-N curves in (Fig 55). All plain coupons failed at random positions along their lengths. Holed non-woven coupons sometimes failed at the holes but frequently away from the holes. Holed woven coupons also frequently failed away from the holes.

Reversed axial fatigue tests on coupons with lay-up E ($\pm 45, 0$), presented in Fig 55, yielded steep S-N plots with coupons failing in compression at significantly smaller stresses than in the tensile fatigue tests. Peak fatigue stresses were reduced to about 350 MPa after 1 million cycles for both the non-woven and mixed woven materials, which corresponds to a coupon strain of approximately 0.5%.
